MISSISSIPPI ENVIRONMENTAL GEOLOGY

David T. Dockery III and David E. Thompson

Mississippi Department of Environmental Quality
Office of Geology
Second Edition, 2019

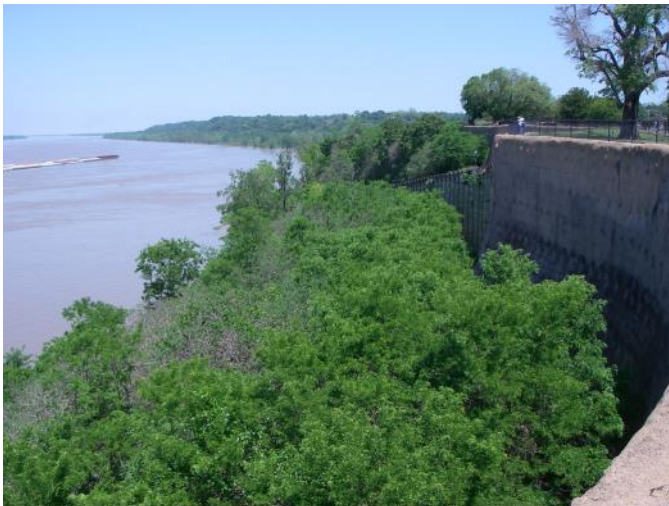
Figure 187. Retaining wall at Natchez, Mississippi, built to protect the upper loess section along the Mississippi River bluff line from slope failure. Picture (digital, CD 37; Image 968) was taken on April 21, 2008.

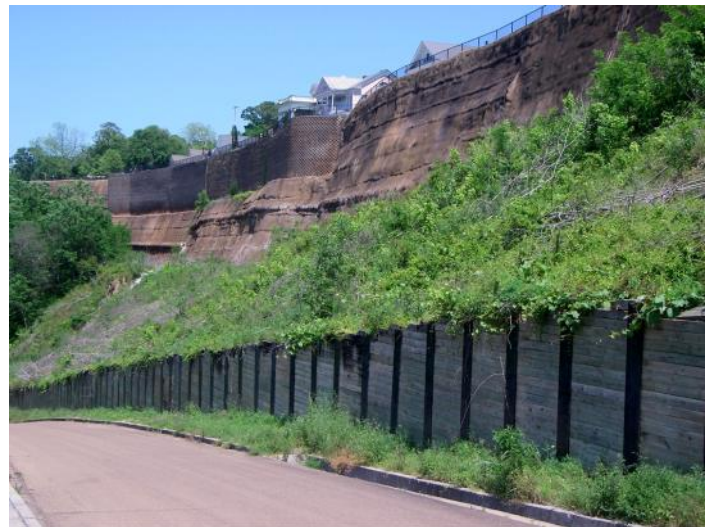
Figure 188. Retaining wall along the Mississippi River bluff line at Natchez, Mississippi, built to protect the loess section of the upper bluff from slope failure. Picture (digital, CD 37; Image 974) was taken on April 21, 2008.

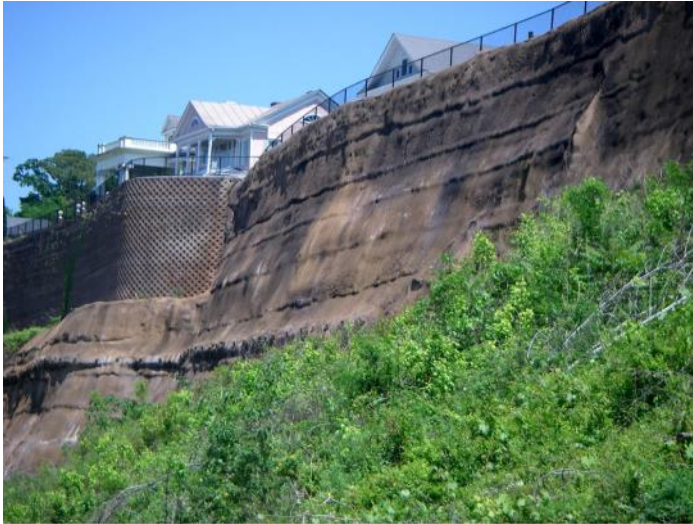
Figure 189. A section of the retaining wall at Natchez, Mississippi, where houses are within 100 feet of the bluff due to slope failures that produced landslides. Picture (digital, CD 37; Image 967) was taken on April 21, 2008.

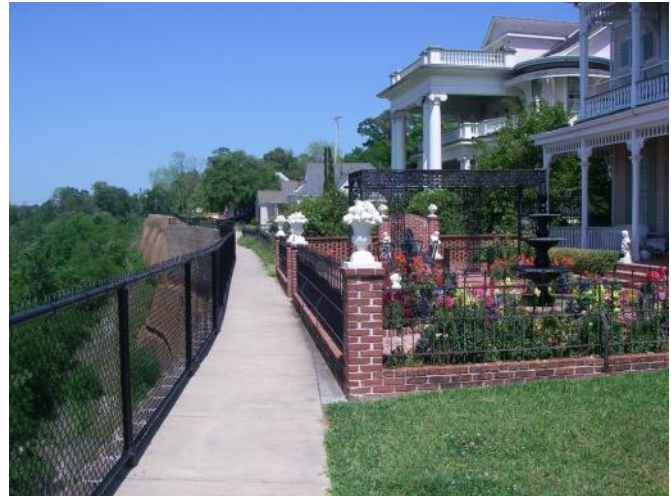
Figure 190. Houses at Natchez, Mississippi, within 100 feet of the edge of the bluff line. The fence along the edge of the retaining wall protects pedestrians from an 80-foot dropoff to the base of the wall. Picture (digital, CD 37; Image 977) was taken on April 21, 2008.

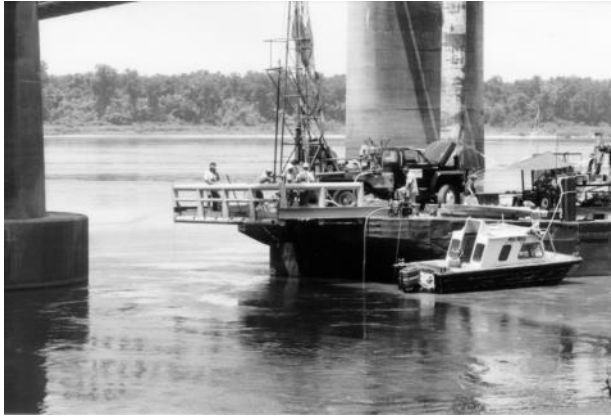
Figure 192. Drilling through a slump block under the Mississippi River between the Interstate 20 and Highway 80 bridges at Vicksburg, Mississippi. Picture (scanned print; Image 1798) taken by Mark Teague.

Figures 192-193 show the drilling of a test hole in the Mississippi River at the Interstate 20 and Highway 80 bridges. The Mississippi Office of Geology ran geophysical logs on this test hole with the logging van on land and the wireline tools ferried to the barge. An earlier test hole, borehole B4, was logged with the van operating from the Interstate 20 bridge, blocking one lane of traffic, and with a spotter at the well head on the barge below. **Figure 194** shows the location of the Interstate 20 and Highway 80 bridges and the location of the cross section in **Figure 195**. To halt movement on the southern end of their property ad-

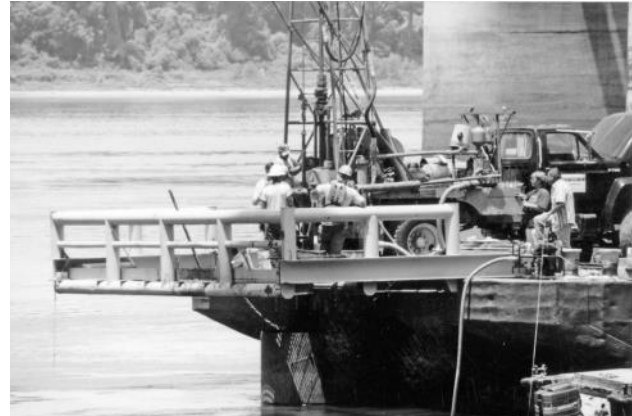
Figure 193. Close-up view of the truck-mounted drilling rig on a barge, drilling through a slump block under the Mississippi River between the Interstate 20 and Highway 80 bridges at Vicksburg, Mississippi. Picture (scanned print; Image 1799) taken by Mark Teague.

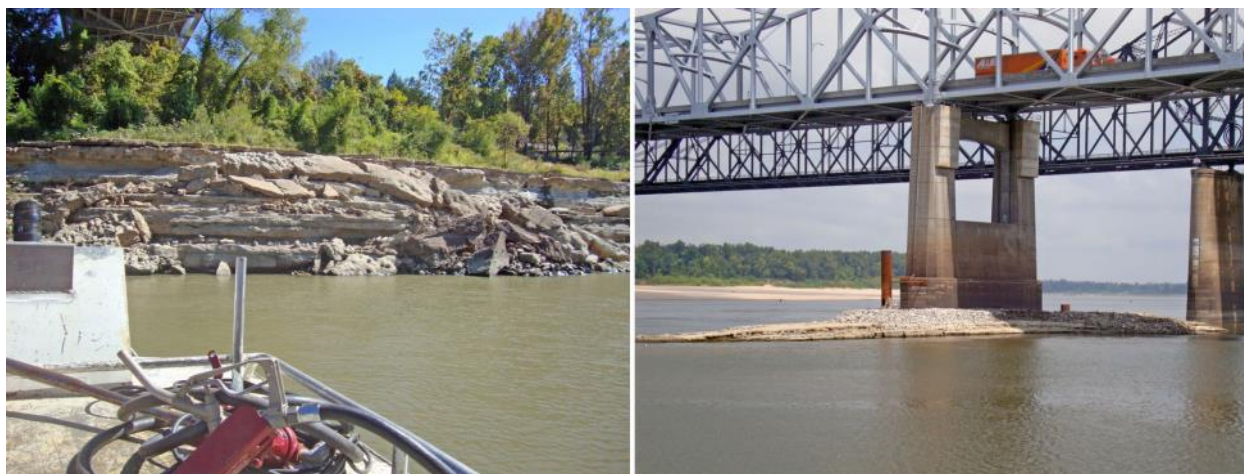
Figure 197. Left: Exposure of Glendon Limestone on the east bank of the Mississippi River beneath the Interstate 20 bridge at Vicksburg. Right: An island of Glendon Limestone in a laterally displaced and down-thrown block, rising out of the river on the south (left) end and plunging beneath the water on the north end in front of Pier E-1 of the I-20 bridge. Picture on left was taken on October 15, 2012, and the picture on the right was taken on August 14, 2012.

Figure 197 (at left) shows the Glendon Limestone in place below the Interstate 20 bridge on the Mississippi River's west bank. At right in Figure 1 is a natural island (exposed only at lower water) on the east side of Pier E-1. This island is composed of a doubly-plunging, north-south-oriented anticline

capped by 15 feet of Glendon Limestone. The picture is a view of the anticline from the southern side. The top ledge of limestone on the island is roughly the top ledge of limestone in the river bank. Low water has afforded the opportunity to drill this island for information concerning possible shear surfaces associated with movement on Pier E-1. The rock comprising the island has moved laterally to the west and is some 15 feet lower than the rock in the neighboring river bank. Drilling on the island began on Monday, October 15 and continued to October 22, 2012. Oriented Shelby tube samples (samples that could reveal shear planes) were taken at five-foot intervals and shipped to a laboratory for examination. The goal of this study is to find a way to stop the

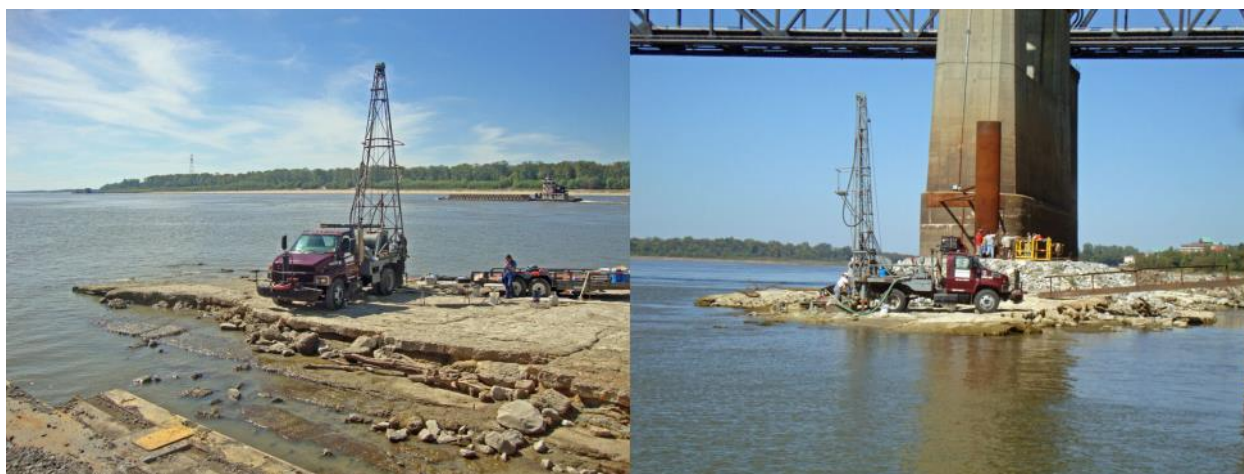
Figure 198. Drilling rig drilling on an island capped by Glendon Limestone in the Mississippi River at Pier E-1 of the Interstate 20 bridge at Vicksburg. At left, the Glendon Limestone plunges below the river level on the south end of an anticline. At right, the vertical pipe behind the rig contains a tiltmeter that measures lateral movement below ground. Pictures were taken on October 15, 2012.

Figure 188 shows the drilling rig on the island. At left in the figure, the drilling rig is shown from the view of the jack-up barge anchored next to the island. The Glendon Limestone can be seen plunging below water level on the south end of the anticline. At right in the figure, a large vertical metal pipe stands above a platform of rip-rap behind the drilling rig. Men are standing around an opening in the base of the pipe in which a ladder leads to an instrument called a tiltmeter. The tiltmeter records subsurface movement along shear planes. Movement of less than an inch has been recorded over the last several years at a

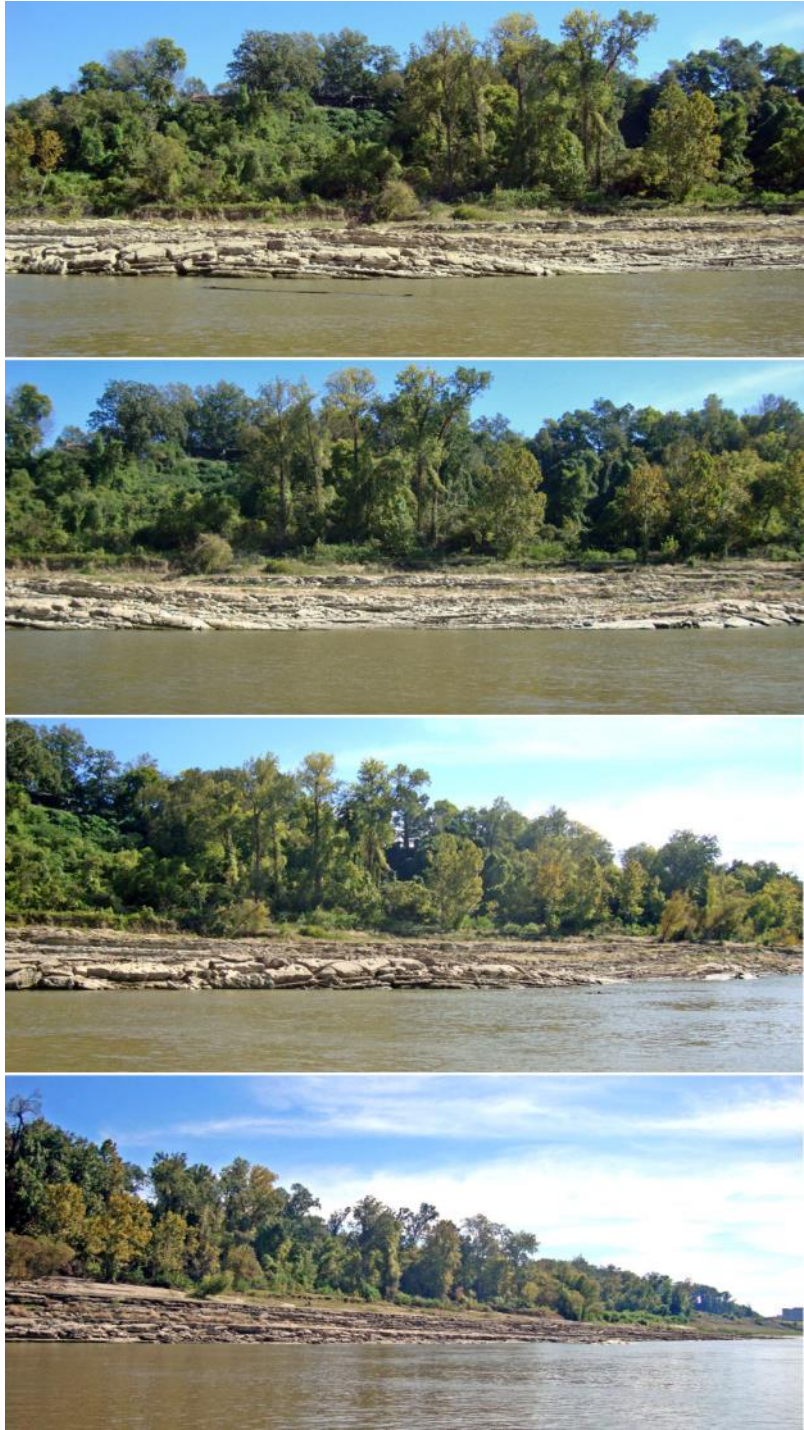
Figure 199. Structure in the Glendon Limestone along the east bank of the Mississippi River at Vicksburg. Pictures were taken on October 15, 2012.

Figure 189 shows geological structures in the Glendon Limestone south of the Interstate 20 bridge. From top to bottom, these structures include: (1) an anticline, with limestone layers cresting above river level, (2) a syncline between two anticlines, with limestone layers sagging below river level, (3) an oblique view of a rising anticline and sagging syncline, and (4) a monoclinial southward dip of limestone strata, sloped like a boat ramp into the river. The latter is the last appearance of the Glendon Limestone along the Mississippi River before it dips beneath younger strata in the southern part of Mississippi. Going north from this southern-most river exposure, the Glendon Limestone makes a gentle rise to exposures in the road cuts along Business Highway 61 in north Vicksburg south of the Vicksburg National Military Park. Further north, the Glendon Limestone was once quarried in the hills along Highway 3 north of Redwood for the manufacture of Portland cement.

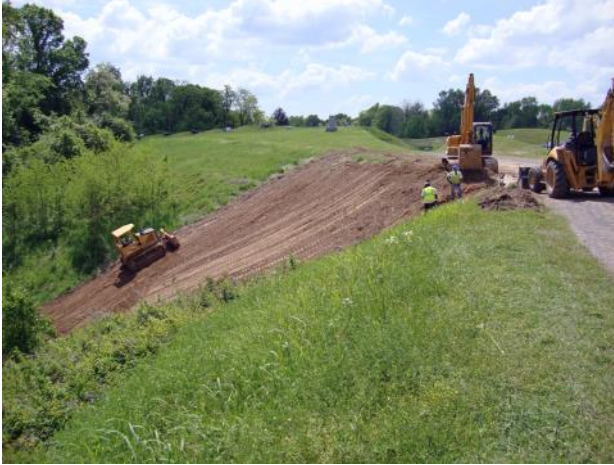
Figure 200. Slope repair on the steep-sided hills in the battle fields of Vicksburg National Military Park. Picture (digital; Image 1929) was taken on April 14, 2010.

Myers et al. (2005) discussed the impact of the Vicksburg loess on the 1863 siege of Vicksburg (**figures 200-203**). Positive impacts for the defenders included; (1) defensible fortifications for both soldiers and civilians, (2) good observation points from the loess hill tops, and (3) a soil that allowed the construction of tunnels and caves as safe places from exploding shells. Negative impacts include: (1) the ability of Union forces to

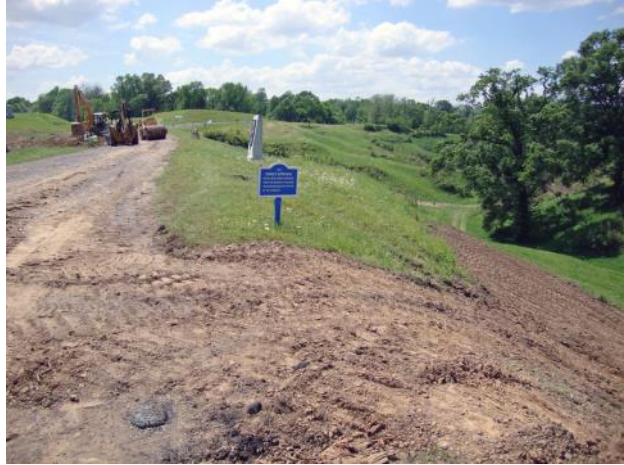
Figure 201. Slope repair on a steep hillside at the marker for Ewing's Approach, which extended from the marker along graveyard road to the distant hillside. Picture (digital; Image 1930) was taken on April 14, 2010.

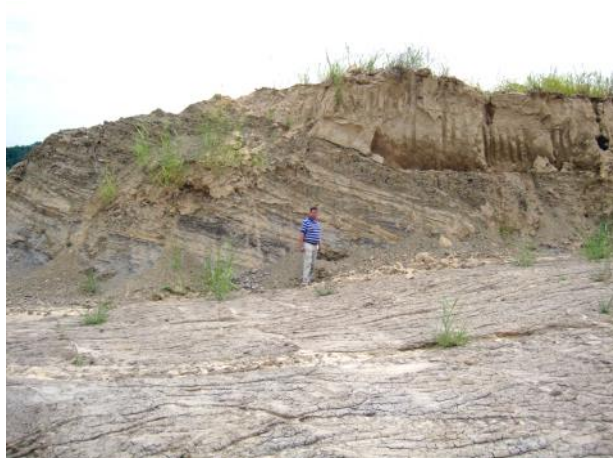
Figure 204. James Starnes standing in front of tilted strata in the Bucatunna Formation rotated in a slump block along the bluff line of the Loess Hills at Keyes Scrap Metal on Highway 61 in north Vicksburg, Mississippi. Picture (digital; Image 1938) was taken on August 24, 2011.

na Formation. These slumps occurred along the bluff line of the Loess Hills where they meet the Mississippi River Alluvial Plain. **Figure 204** shows a rotated slump block with tilted beds of the Bucatunna Formation. **Figures 205 and 206** show the shear plane of a second overlying slump block, where loess is in sharp contact with the Bucatunna Formation and the pre-loess gravel is missing. A normal section of Bucatunna, pre-loess gravel, and loess is present in an adjacent excavation-cut exposure. **Figure 207** shows a slump fault with a slumped block of loess to the left against a normal section of pre-loess

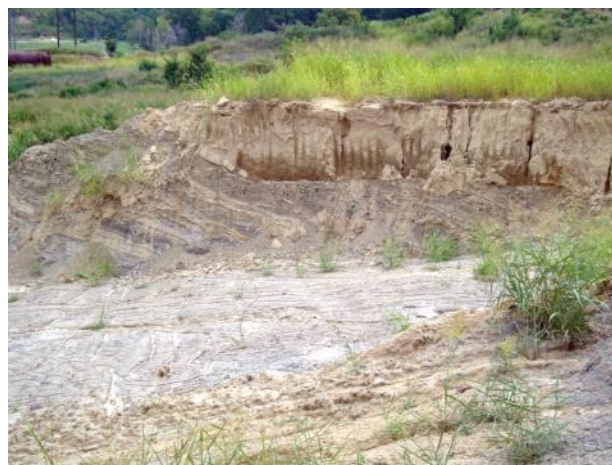
Figure 205. Above the slumped and tilted beds of the Bucatunna Formation at Keyes Scrap Metal on Highway 61 at Vicksburg is the fault shear plane of an overlying slump block containing loess in sharp contact with the underlying stratified clay. Picture (digital; Image 1941) was taken on August 24, 2011.

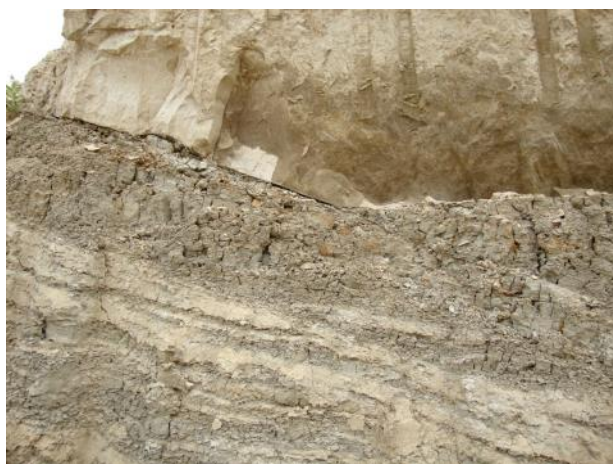
Figure 206. Shear plane between two slump blocks at Keyes Scrap Metal on Highway 61 at Vicksburg, Mississippi. The lower slump block contains Bucatunna Clay; the upper slump block contains loess. The pre-loess gravel is missing in this section. Picture (digital; Image 1939) was taken on August 24, 2011.

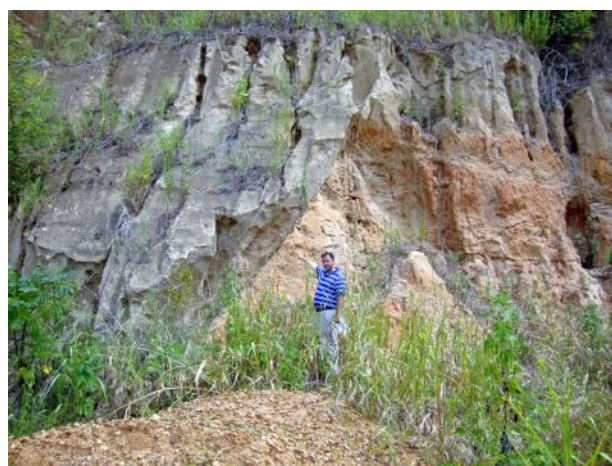
Figure 207. James Starnes pointing to a slump fault with loess down to the left and pre-loess sand and gravel with overlying loess in place to the right at Keyes Scrap Metal on Highway 61 at Vicksburg, Mississippi. Picture (digital; Image 1940) was taken on August 24, 2011.

overlying loess in place to the right. Even though the pre-loess gravel has a rough texture, the contact along the shear plane with the loess is amazingly sharp and regular. An in-place sequence of pre-loess gravel and loess was present out of view to the left side of the photograph in **Figure 207**.

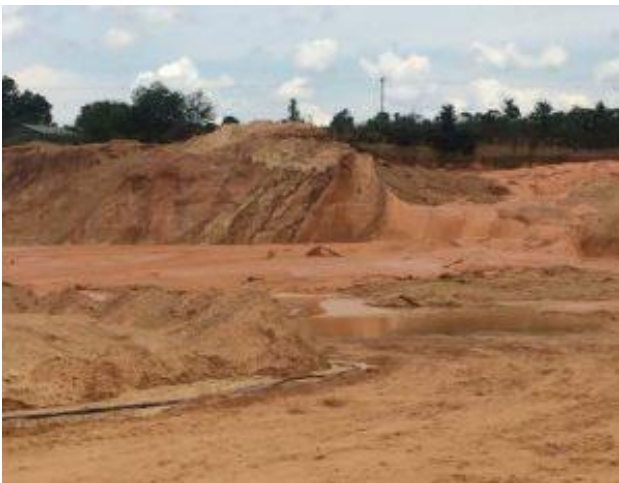
Figure 209. Failed high wall between the Johnson Pit at lower left and the Ball Pit at upper right from MSHA Report MAI-2016-7/8. Image 2521.

According to the MSHA Report of Investigation MAI-2016-07/8, Hemphill was loading Shorter about 50 feet west of the Johnson Pit wall, while Shontavious Noral was parked west of the loading operation, waiting to be loaded in his truck. "Norals observed the east wall of the Johnson Pit begin to break and slurry and tailings (waste sand and clay) material breach the wall. He shifted his truck into reverse and backed up the bank on the west side of the pit, before shifting into a forward gear to exit the pit, as the material engulfed the

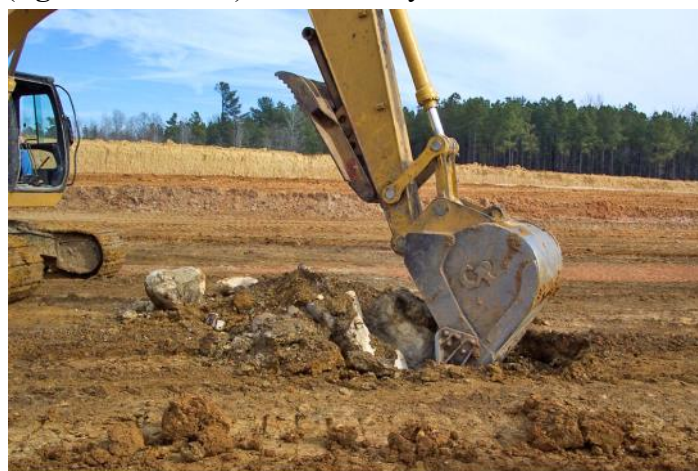
Figure 214. A backhoe excavates pinnacles of limestone, at the request of MDEQ geologists, from swelling clays in the Glendon regolith under the graded foundation for the new Brandon High School. This soil proved unsuitable as foundation material and was removed at a considerable cost overrun. Picture (digital, CD 44: Image 999) was taken by Stephen Jennings on January 28, 2004.

During our visit to the high school site, Steve Jennings asked a trackhoe operator to dig beneath an area that appeared to be weathered limestone. A large mass of Glendon Limestone was found just below the surface (**figures 214-215**). Eventually, the Glendon

regolith layer had to be removed from the site and replaced with suitable foundation material at a cost overrun estimated at four million dollars. The cost of the Rankin County geology bulletin, along with its geologic map, was just three dollars. Though this bulletin is now out of print, it can be viewed for free at the MDEQ library. **Figure 216** shows a field of limestone boulders, which had to be removed from beneath the High School foundation before the school could be built. **Figure 217** is a picture of the Hinds Community College (Rankin County Campus) Physical Geology Class (fall of 2009) on a field trip to an outcrop of the Marianna Limestone and overlying Glendon Limestone on Highway 18 about 3.5 miles west of Brandon High School.

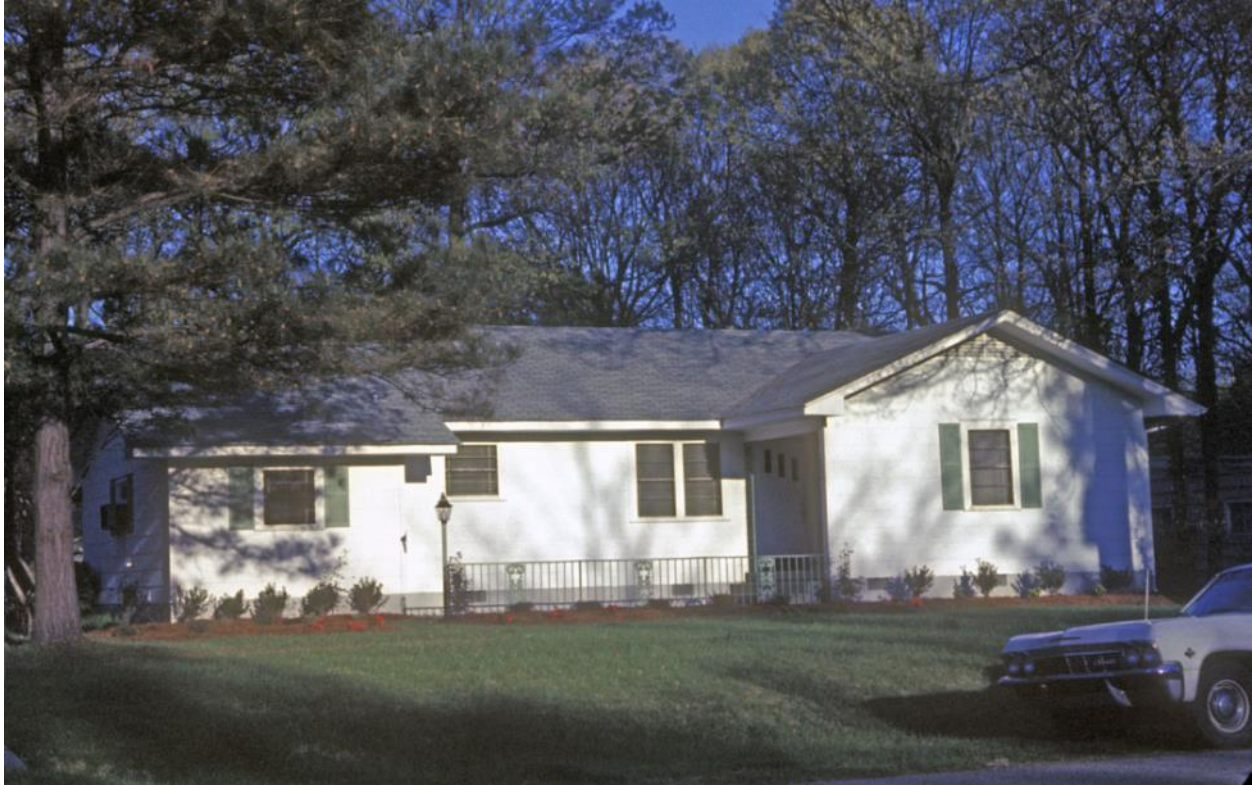
Figure 218. Dockery home at 4550 Manila Drive built in a GI subdivision in north Jackson in 1949 on a foundation of eighteen 20-foot-deep piers and a poured concrete perimeter skirt. At left is the garage (converted to a room) on slab; at right is the L-shaped house on piers. Picture (slide; Image 1935) was taken in March of 1974.

As was probably true for all lots in the GI subdivision, the Manila Drive lot rested on weathered Yazoo Clay. The building contractor drilled 18 boreholes for pilings to a depth of 20 feet (a depth necessary to penetrate the weathered expansive clay to the blue-gray stiff unweathered clay). The holes were filled with reinforcing steel and concrete and served as foundation piers for the house. Then the contractor poured a concrete skirt foundation for the house perimeter. The wooden floor and superstructure were built on the concrete skirt and pilings. A crawl space between the floor

and the ground provided room for the Yazoo Clay to rise and fall with the wetting and drying of the soil. We never had any foundation problems with this house (**Figure 218**).

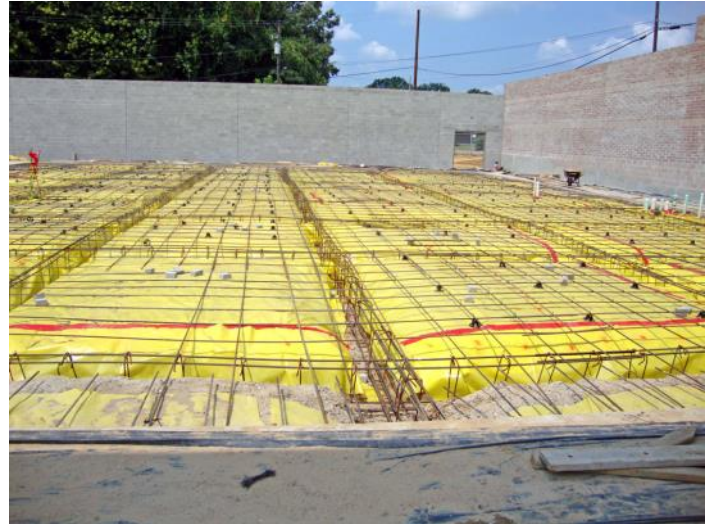
Figure 228. Form for a monolithic beam-on-grade foundation as viewed from the front of a discount store building in Clinton, Mississippi. The slab of the previous building had buckled some two feet out of level. Picture (digital; Image 1959) was taken on August 8, 2011.

One example of damage to a commercial building with a slab foundation was a discount store in Clinton, Mississippi, in which the slab heaved some two feet out of level. The store was closed; the building was demolished, and the slab and 8 to 10 feet of the underlying fill and Yazoo Clay were excavated and replaced with an equal thickness of a non-expansive fill buffer. Above this was construction a monolithic beam-on-grade foundation. **Figures 228 and 229** show the form for the beam-on-grade foundation for the interior floor before the concrete was poured.

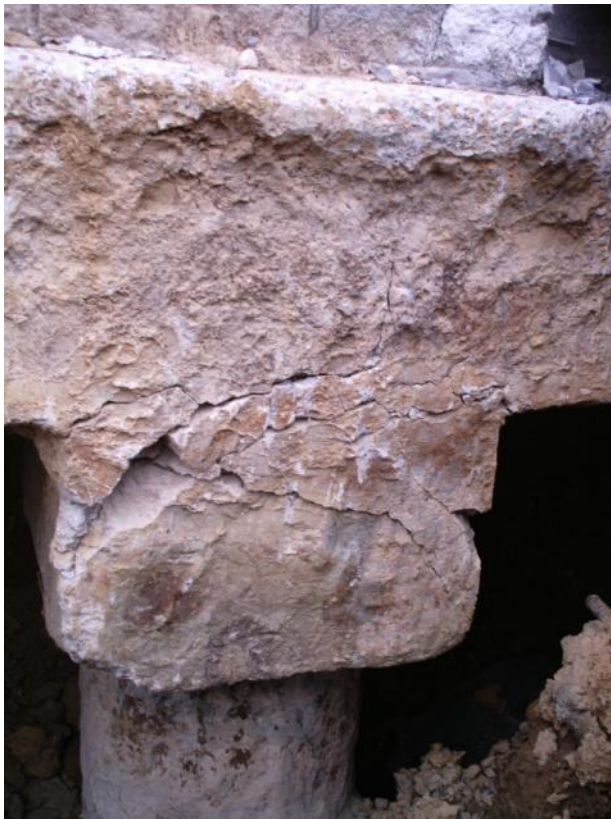
Figure 231. Damaged due to clay heave at the junction of a drilled pier and beam with a six-inch crawl space on fill overlying the Yazoo Clay in a Jackson apartment building. Picture (digital; Image 1977) was taken by Britt Maxwell in 1981.

Figure 230 at top illustrates foundation damage due to an uneven surface above the active zone of the Yazoo Clay beneath the structure. At left and above (**figures 231-232**) are pictures of damage to a Jackson apartment building caused by vertical clay heave that closed a six-inch crawl space before lifting the foundation. On the opposite page (**figures 233-235**) is damage to a three-story nursing home in Jackson caused by lateral heave shearing piers.

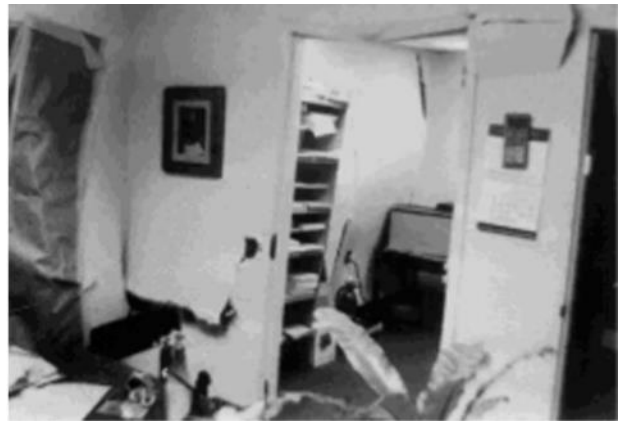
Figure 232. Damage inside the apartment building due to clay heave closing up the six-inch crawl space beneath foundation and buckling the floor. The walls are compressed; the sheet rock is torn, and the doorways are warped. Picture (digital; Image 1978) was taken by Britt Maxwell in 1981.

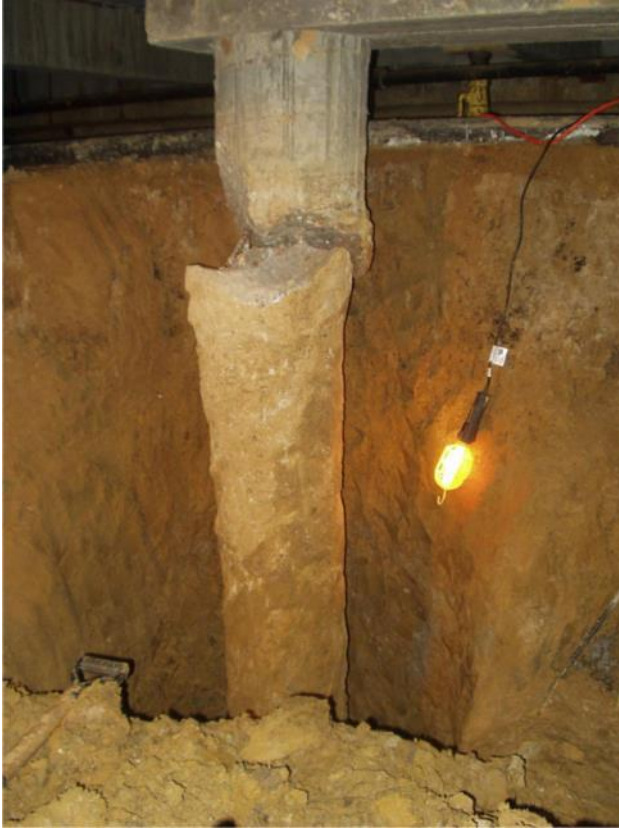
Figure 233. A 24-inch concrete pile that was sheared because the Yazoo Clay was removed in a trench from one side to repair a sewer line and not the other side, and because the fill in the trench was not properly compacted. It took just four months for clay to move into the poorly-compacted trench and shear the pile. A total of 32 piers were sheared under the interior cross beams of a 3-story nursing home in Jackson, Mississippi. Picture (digital; Image 1961) was taken by John Ray.

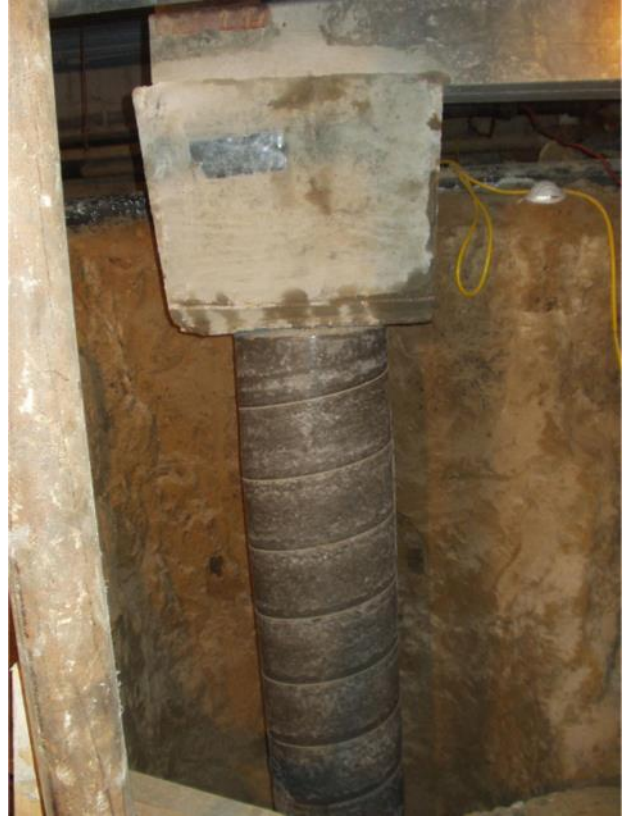
Figure 234. Replacement pile constructed by Ewing and Ray Foundation Services. A total of 32 piers were sheared by clay movement under the interior cross beams of a 3-story nursing home in Jackson, Mississippi. Picture (digital; Image 1962) was taken by John Ray.

An example of Yazoo Clay causing damage by lateral movement occurred in a 30-year-old, three-story nursing home built on piers in Jackson, Mississippi. A pipe below the building was sheared in the clay and had to be repaired. The pipe was excavated by a trench in the crawl space between two rows of piers and was repaired. The trench was back-filled without sufficient compaction of the fill. Within four months lateral movement of the clay into the poorly-compacted trench sheared the piers on one side of the trench. A total of 32 piers were sheared under the interior cross-beams of the nursing home (figures 233-235).

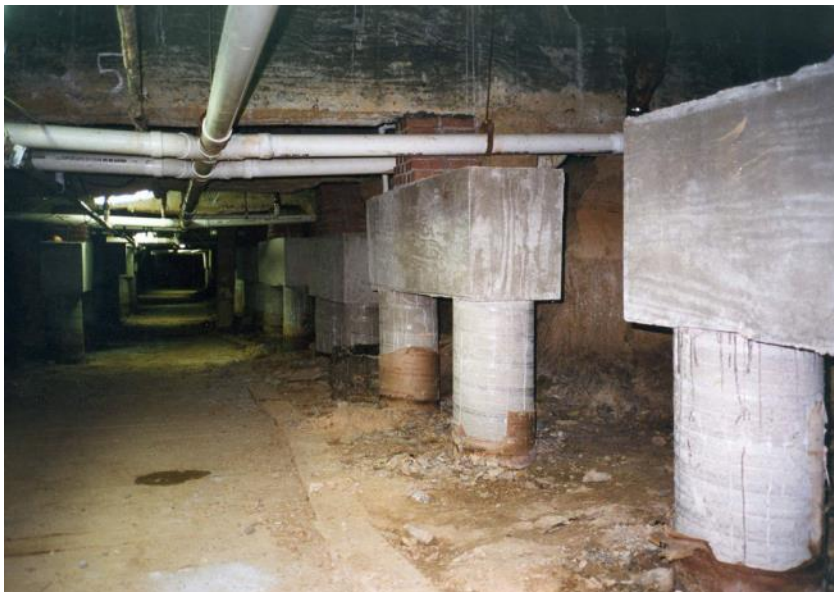
Figure 235. At left, twin piles supporting pike caps with brick pyramids to support the interior beams. These piles were construction by Ewing and Ray Foundation Services to replace piles sheared by clay movement under a 3-story nursing home in Jackson, Mississippi. Picture (digital; Image 1963) was taken by John Ray.

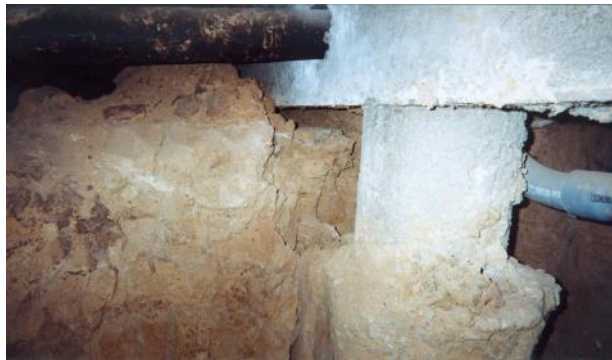
Figure 237. Vertical heave of clay around a grade beam, where there was once a 5-foot clearance under the grade beam. Picture (digital; Image 1965) was taken by John Ray.

Maxwell (personal communication) found from yearly measurements that the Yazoo Clay tends to heave at a certain rate every year. **Figure 236** shows variable heave rates for the Yazoo Clay and the repair strategies needed for the various rates. **Figure 237** shows clay heave that has closed the space under a grade beam, and **Figure 238** shows where clay shrinkage has left a gap between the grade beam and pier (and all under the same building in Jackson, Mississippi).

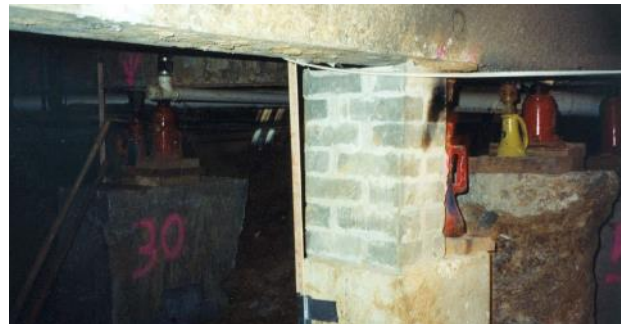
Figure 238. At right, clay has shrunk under a 20-foot deep pile and left the grade beam resting on adjoining concrete piles. There is a 1.5-inch space between the top of the brick pier that is resting on the top of the concrete pile and the bottom of the grade beam. Picture (digital; Image 1966) was taken by John Ray.

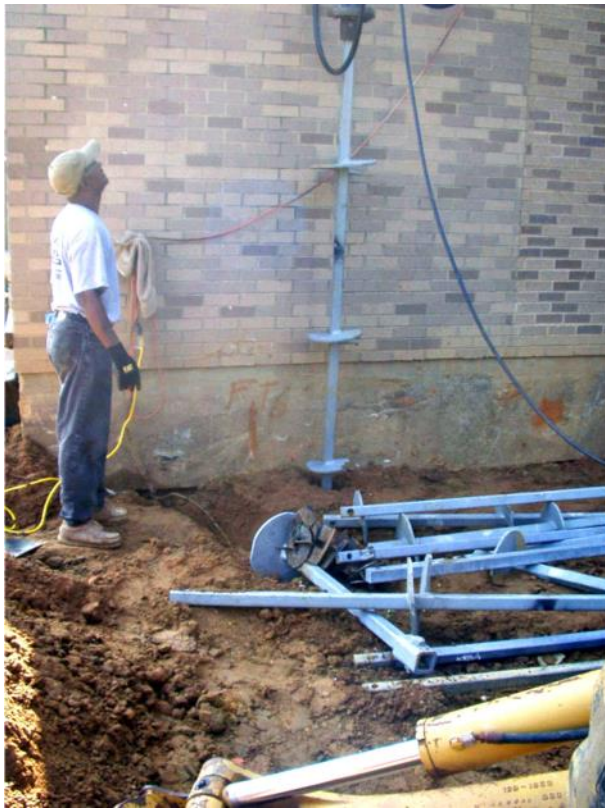
Figure 239. Installation of a helical pier. Helical piers with a grouted column to carry heavier loads and to resist lateral load. Picture (digital; Image 1000) was taken by John Ray.

Helical piers (**Figure 239**) with grouted columns can carry heavy vertical loads and resist lateral loads. This type of pier was used by Ewing and Ray Foundation Services to lift cell towers, a railroad switch tower, and a

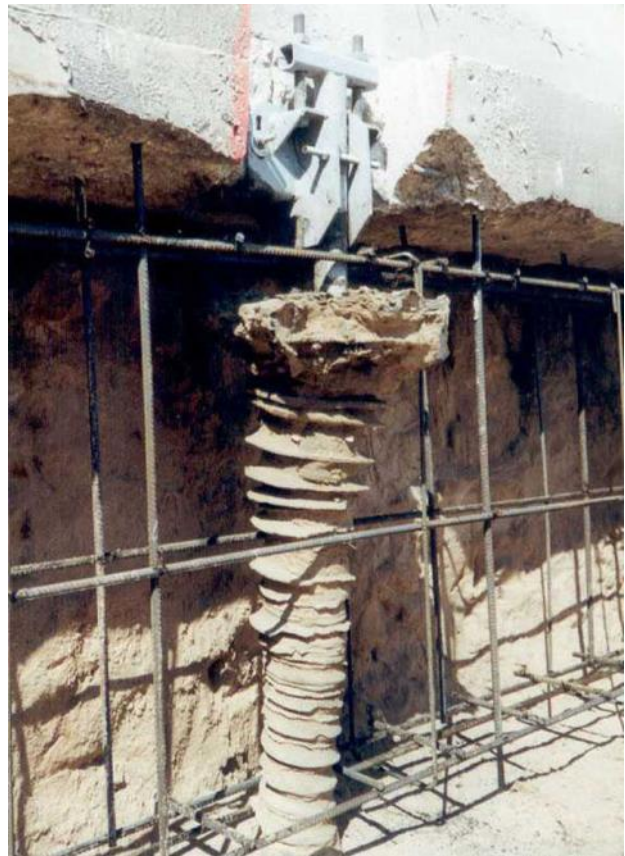
Figure 240. A grouted helical pier uncovered to allow another foundation to be set adjoining the existing foundation, where an undercut was required. Picture (digital; Image 1978) was taken by John Ray.

pumping station in New Orleans after Hurricane Katrina. **Figure 240** shows the excavated grouted helical pier uncovered to allow another foundation to be set adjoining the existing foundation.

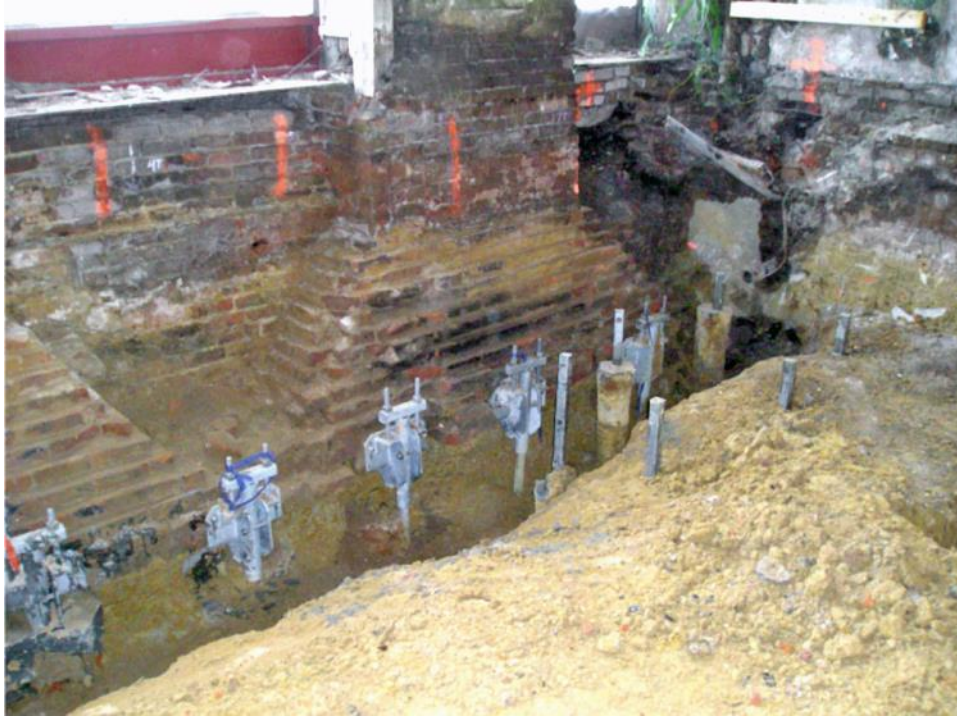
Figure 241. Brick pyramid footings under the Grand Opera House in Meridian, Mississippi, which was built in 1900 and was restored in 2000. Helical piers are in place for a new foundation. Picture (digital; Image 1970) was taken by John Ray.

Grouted helical piers were used in making a new foundation for the Grand Opera House in Meridian, Mississippi (**Figure 241**). The Grand Opera House was built by German-Jewish immigrants in the late 1800s at a time that Meridian was a booming timber and commercial center. It was completed in 1890. In 2006, the building underwent a \$25 million reconstruction to become the MSU Riley Center for Education and Performing Arts.

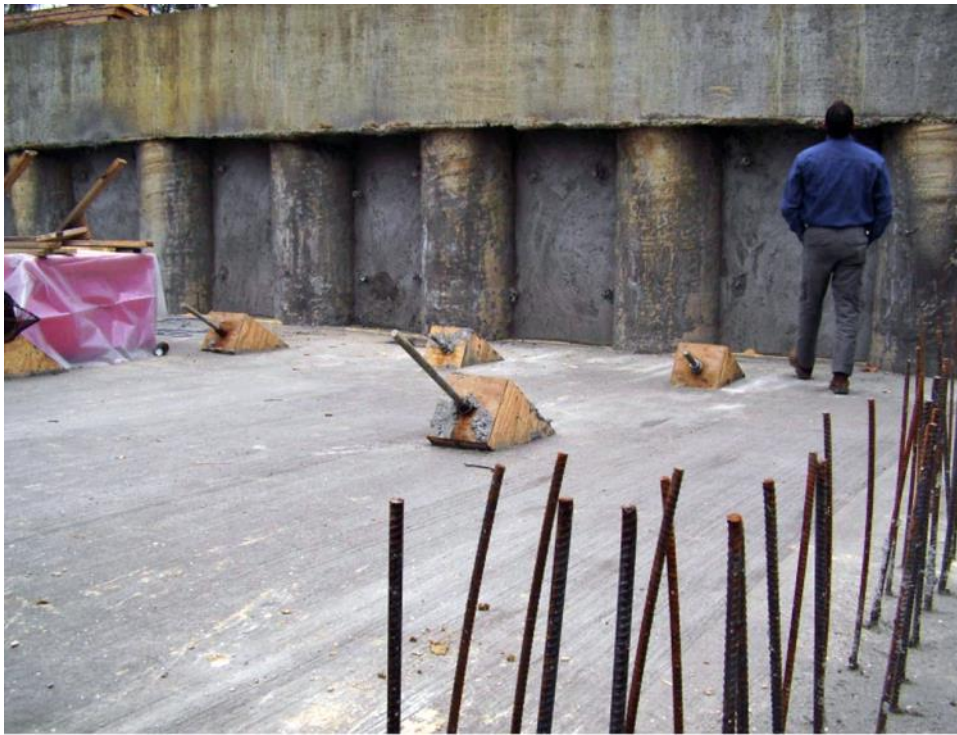
Figure 242. A special house foundation built on the Ross Barnett Reservoir with concrete piles as part of the foundation and with helical piers used soil nails to hold back the concrete piles and to hold the toe of a slope failure in the Yazoo Clay. Picture (digital; Image 1970) was taken by John Ray.

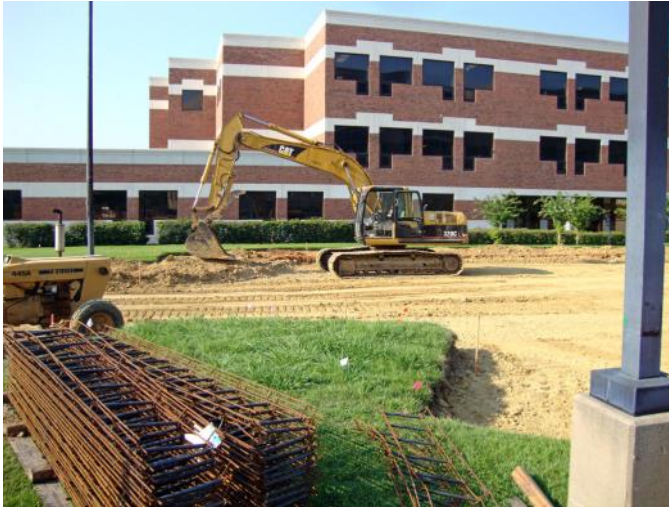
Figure 243. Excavation and back fill of sand to replace the old concrete drive and parking area of Jackson's downtown Post Office, which buckled with some slab sections higher than others, and replacing it with a new concrete drive. Picture (digital; Image 1967) was taken on August 26, 2011.

Yazoo Clay Damage. Examples of damage in Jackson, Mississippi, caused by the Yazoo Clay, as shown above, include the buckling and replacement of the Downtown Post Office concrete drive and parking area (**Figure 243-244**), the Eudora Welty house in the Belhaven community (**Figure 240**), and an unrepaired brick house on North State Street (**Figure 246**).

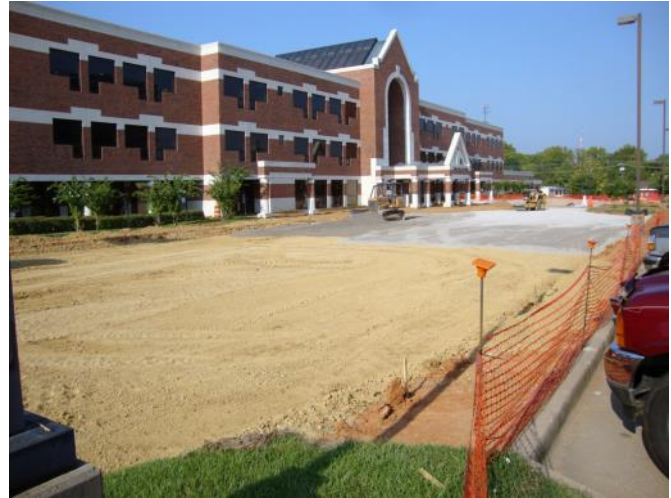
Figure 244. Sand back fill and overlying crushed limestone fill (in the distance) for a new concrete drive and parking at Jackson's downtown Post Office. Picture (digital; Image 1968) was taken on August 26, 2011.

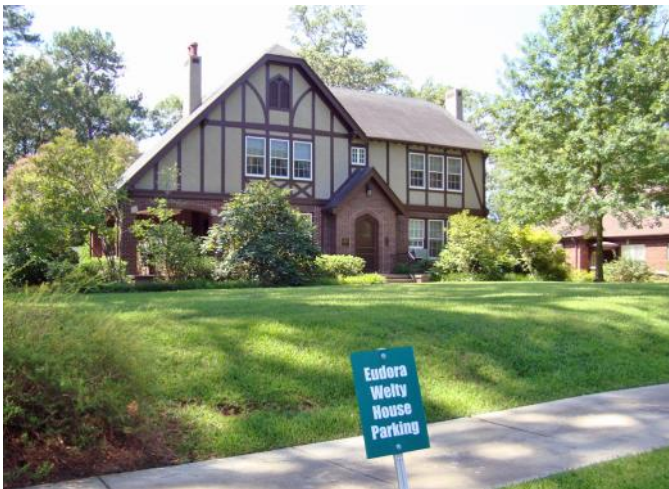
Figure 245. The Eudora Welty house in Jackson was re-levelled due to heave damage by the Yazoo Clay. Picture (digital; Image 1969) was taken on August 12, 2011.

The Eudora Welty house in **Figure 245** is shown in its restored condition. The house was built in 1925 and had foundation repairs made in 1979 and 2002. Both repairs were made by Robert Ewing. Soil boring at the four

corners of the house showed 5 feet of nonexpansive clay underlain by 22 feet of expansive weathered Yazoo Clay. The unweathered blue Yazoo Clay was encountered at an average depth of 27 feet. In the 2002 repair, the whole house was jacked up and leveled and 50 drilled piers were placed under the foundation, each seated 5 feet into the unweathered Yazoo Clay (Ewing, 2011). In 2005 the Eudora Welty house was placed on the National Register of Historic Places, due to Miss Welty's influence on our national literary heritage and because she did her writing from the her upstairs bedroom.

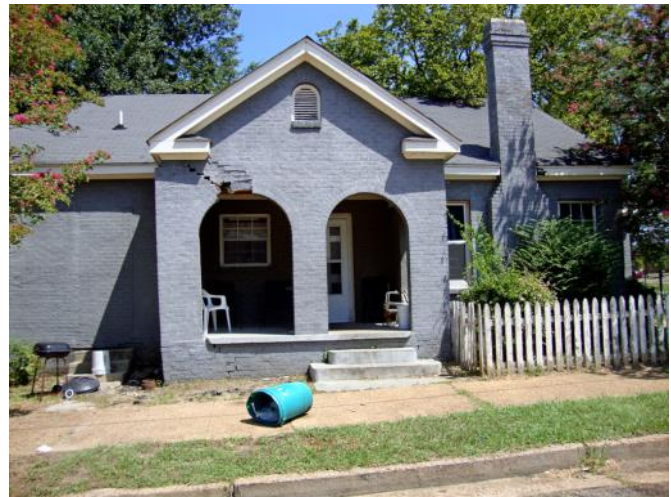
Figure 246. Brick damage on the porch of a Jackson home due to a shifting foundation. Picture (digital; Image 1970) was taken on August 12, 2011.

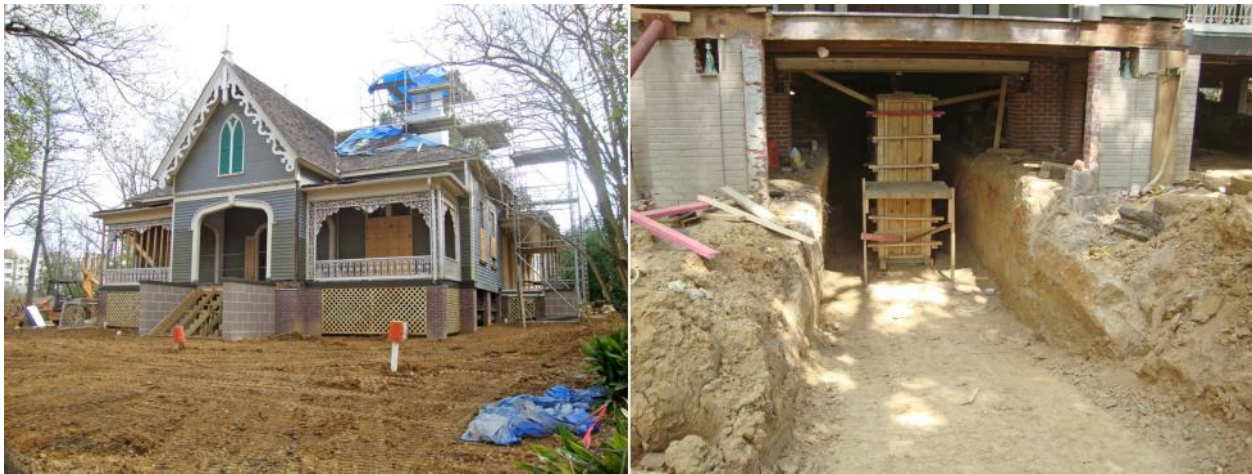
Figure 247. Left, Manship House with new foundation and reconstructed chimneys. Right, construction of new piling at front of house. Pictures (digital; Image 2317) were taken on January 29, 2013, on left and August 2, 2012, on right.

The *Clarion-Ledger* article reported that, in addition to historical artifacts found during the excavation, there were “blue-tinged hunks of fossil-dotted clay” in the “stable layer 40 feet down.” In August 2012, I answered a request from Manship House Museum director Marilynn Jones to examine the fossils excavated from the construction of the building’s new pilings (**Figure 247**). As it happened, I arrived to examine the excavated spoil when no work-

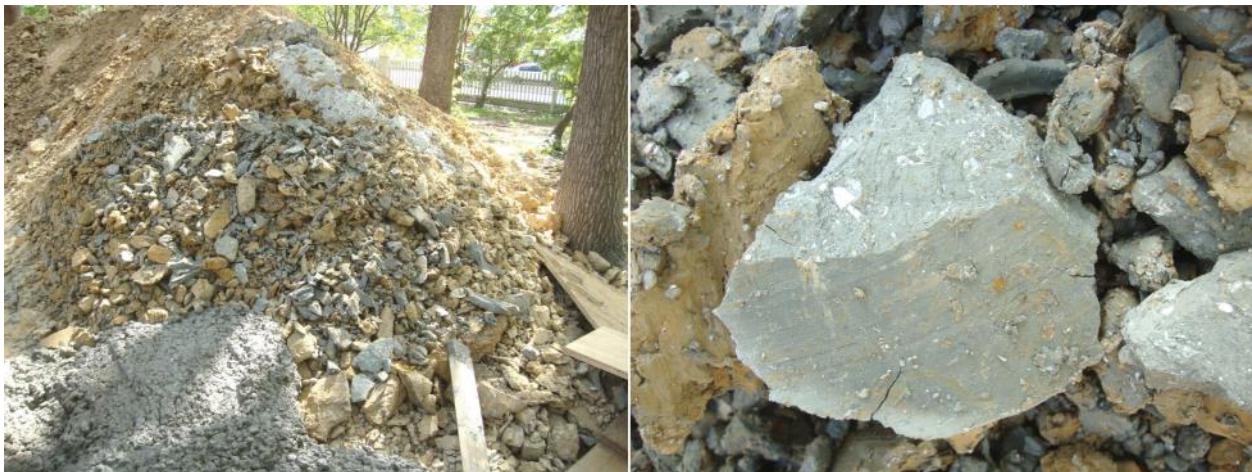
Figure 248. Left, Yazoo Clay excavated from a hole for a new piling at the Manship House Museum. Left, reverse stratigraphy—weathered brown Yazoo Clay on bottom, unweathered blue-gray clay on top. Right, close up of unweathered Yazoo Clay with chalky fossil seashells. Pictures (digital; Image 2318) were taken on August 2, 2012.

ers were present. The spoil contained cuttings of bedrock strata in reverse order, with the brown weathered Yazoo on the bottom and the unweathered blue-gray clay from the “stable layer” forty feet down on top. The blue-gray Yazoo Clay contained chalky fossil seashells (**Figure 248**).

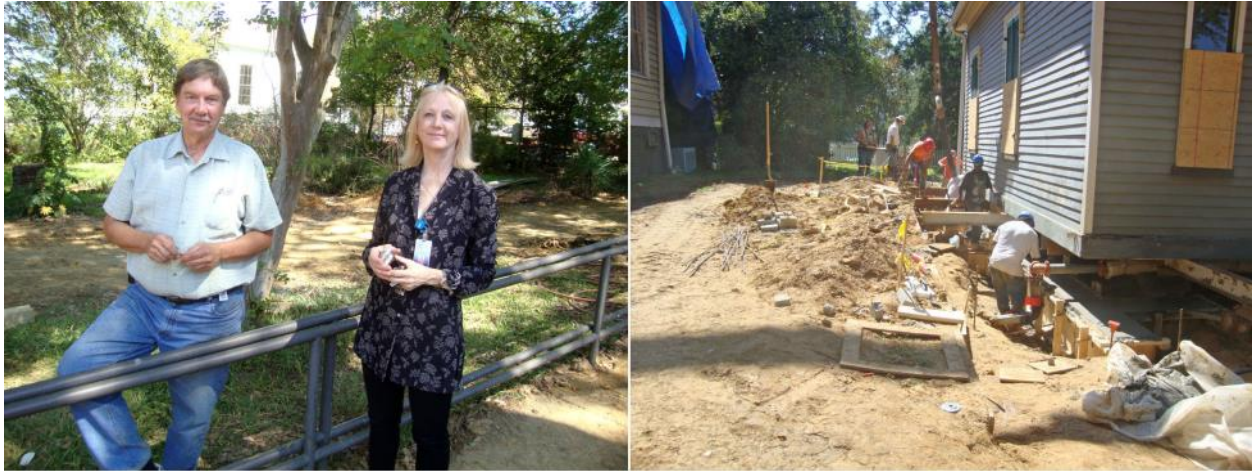
Figure 249. Left, site engineer Britt Maxwell and Manship House Museum director Marilyn Jones. Right, the Manship House rests on steel I beams as a new perimeter skirt foundation is poured by a trailer-mounted boom cement pump. Pictures (digital; Image 2319) were taken on October 5, 2012.

In October of 2013, work on a new perimeter foundation skirt was underway in spectacular fashion with a trailer-mounted boom concrete pump, pumping concrete over a building to the foundation site (**Figure 249**). Usually when I (Dockery) go with a camera to a construction site, I’m greeted by a big burly foreman who wants an account of what I’m doing—but, not this time. The big burly man was the site engineer, Britt Maxwell, a class-
